September 2006

SIP TIP: WHAT IS WRONG WITH THIS PICTURE?

NOVEMBER 2005: WHAT IS WRONG WITH THIS PICTURE

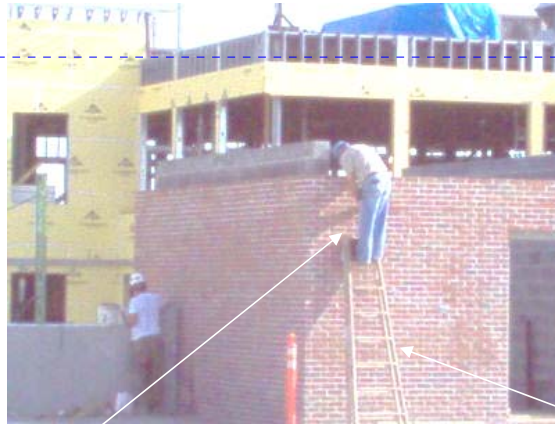
What is the hazard? Worker standing on the next to top step of a step ladder, Step ladder leaning against the wall

How can the hazard be fixed? Use the proper ladder for the job – use an extension ladder of the right length set up at the right angle (4 to 1).

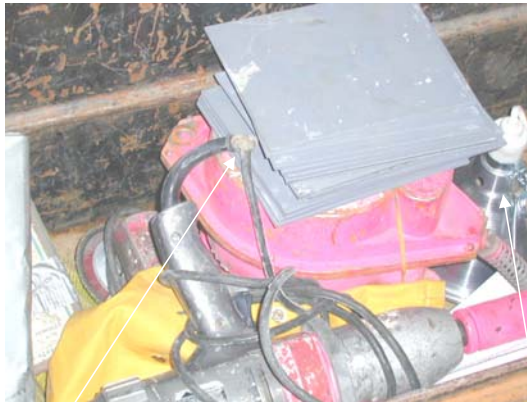
What is the hazard? Drill with broken cord and non-grounded spot light with metal housing

How can the hazard be fixed? Tag Drill and have repaired and remove spot light from job and get the proper equipment (grounded spot light)
